Causes and Probability of Premature Fatigue Cracks in Railway Axles

Cwiek Janusz
Department of Transport and Aviation
Engineering
Silesian University of Technology
Katowice, Poland
janusz.cwiek@polsl.pl

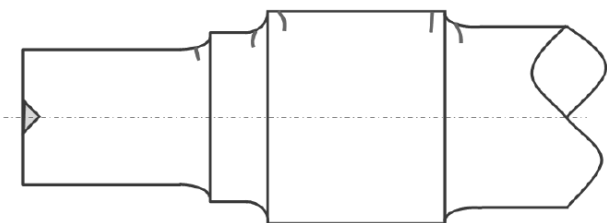
Due to the distribution of cyclic stresses in rotational bending in the axis, the greatest bending moments occur in the section axle journal – dust collar – wheel seat - a radius of transition from the seat to the body of an axle. This is also where fatigue cracks initiated on the axle surface occur most

Fig. 1. The places of the railway axle most exposed to the occurrence of fatigue cracks [1]

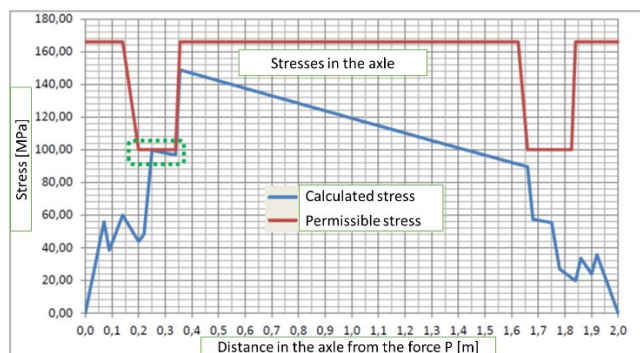
Fig. 2 shows the distribution of the maximum stresses in the tested axle, after applying a load in accordance with the EN 13103 standard, and their reference to the permissible stresses [3]. The diagram shows that the design stresses locally within the wheel seat have reached the level of allowable stresses (the area marked in green).

Fig. 2. Stresses in the tested railway axis [3]

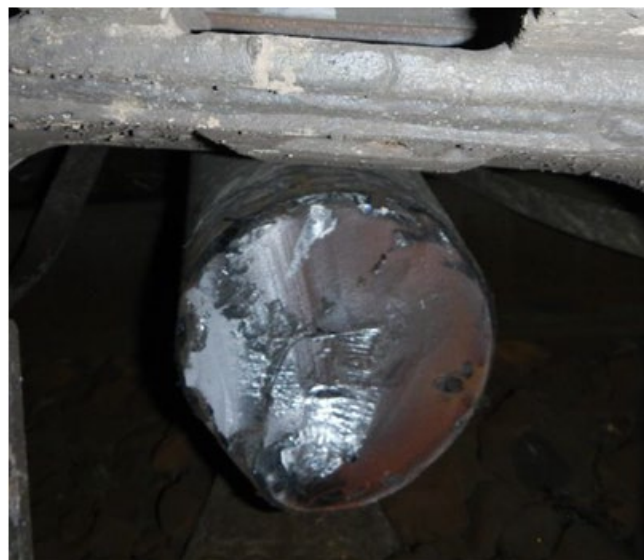
The fatigue crack shown in Figure 4 and Figure 5 derives from the B11 accident of the freight wagon in 2015 [4]. The immediate cause was a fatigue crack in the middle part of the first axle of the first wheelset, while the primary cause was an old surface defect of the axle. A crack has taken place on the axle body. The origin of the crack was the surface defect unnoticed during inspection. The smaller area of the fatigue zone and the larger area of the rapid fracture zone indicate high loads on the axle. The lack of stop and radial lines indicates the rapid development and propagation of the crack that took place on the presented fracture surface. Numerous defects and pitting can be seen on the axle surface, moreover, the shape of the axle is deformed as a result of a derailment of the train.

Fig. 5. Fatigue cracking surface of the axle of the freight wagon [4]

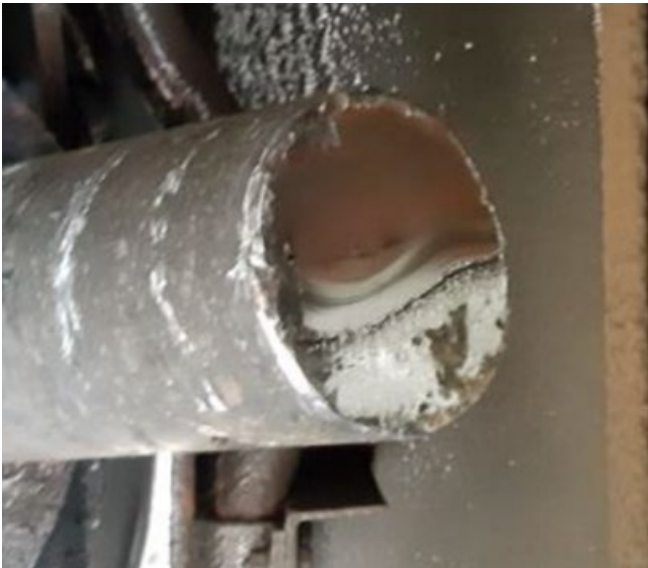
Another example of fatigue cracking classified as B11 accident is from the derailment of a freight wagon in 2019 [4]. The immediate cause of the incident was a fatigue fracture in the middle of the axle body of the third axle in a wagon. The origin of the crack was the surface defect of the wheelset axle. This axis was subjected to lower bending and rotational loads, which indicates a larger area of the fatigue zone compared to the rapid fracture zone and the presence of stop lines (Fig. 6). The development of the fracture progressed slowly, as indicated by the stop lines.

Fig. 6. Fatigue cracking surface of the axle of the freight wagon [4]

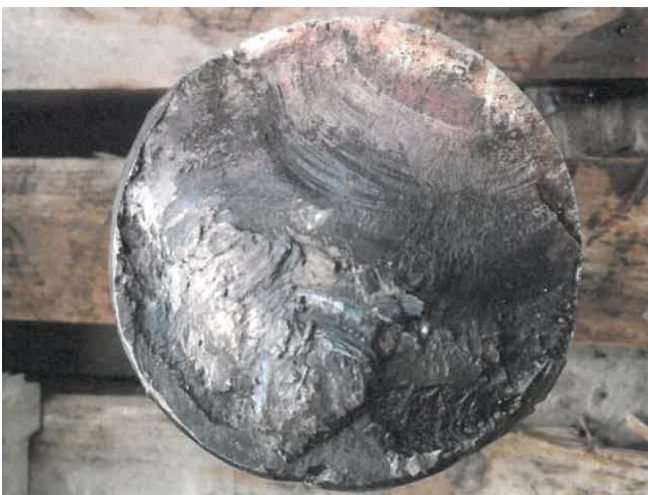
Last example of B11 accident with fatigue cracking is from the derailment of a freight wagon in 2019 [5]. The immediate cause of the incident was a fatigue fracture in the journal of the axle (Fig. 7). It can be seen from Fig. 8 that about 40% of the cross-section is fatigue area, which indicate high loads on the axle. The primary cause is improper machining of the axle surface (Fig. 9), i.e. undercut, which resulted in an unfavorable distribution of stresses in the axle and initiation and development of fatigue crack.

Fig. 8. Fatigue cracking surface of the axle of the freight wagon [5]

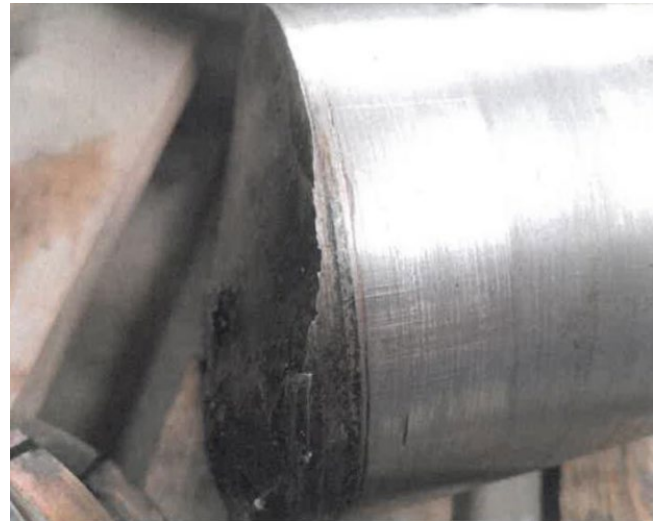
Fig. 9. The fatigue fracture area of the axle journal with visible undercutting [5]
