Causes and Probability of Premature Fatigue Cracks in Railway Axles

Cwiek Janusz
Department of Transport and Aviation
Engineering
Silesian University of Technology
Katowice, Poland
janusz.cwiek@polsl.pl

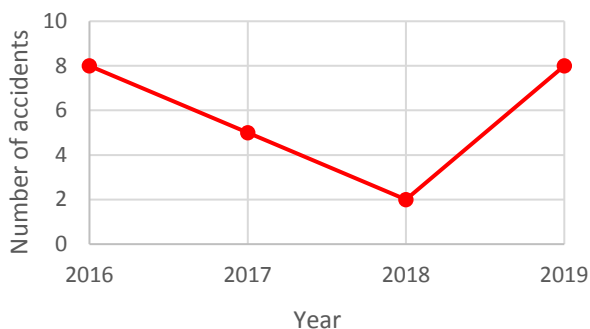
From 2016 to 2019 twenty three B11 accidents occurred in Poland (Fig. 3) in which the direct cause was the fatigue crack of the axle (data derived from reports of State Railway Accident Investigation Commission). The scope of data submission starts in 2016, as from this year all infrastructure and siding managers are required to report incidents to the Commission.

Fig. 3. Number of category B11 accidents, in which the axle fatigue cracking took place
